Supplemental Service Manual

906-2150-002 Rev. C, TEXT ONLY

***Centurion** Vision System Supplemental Service Manual**

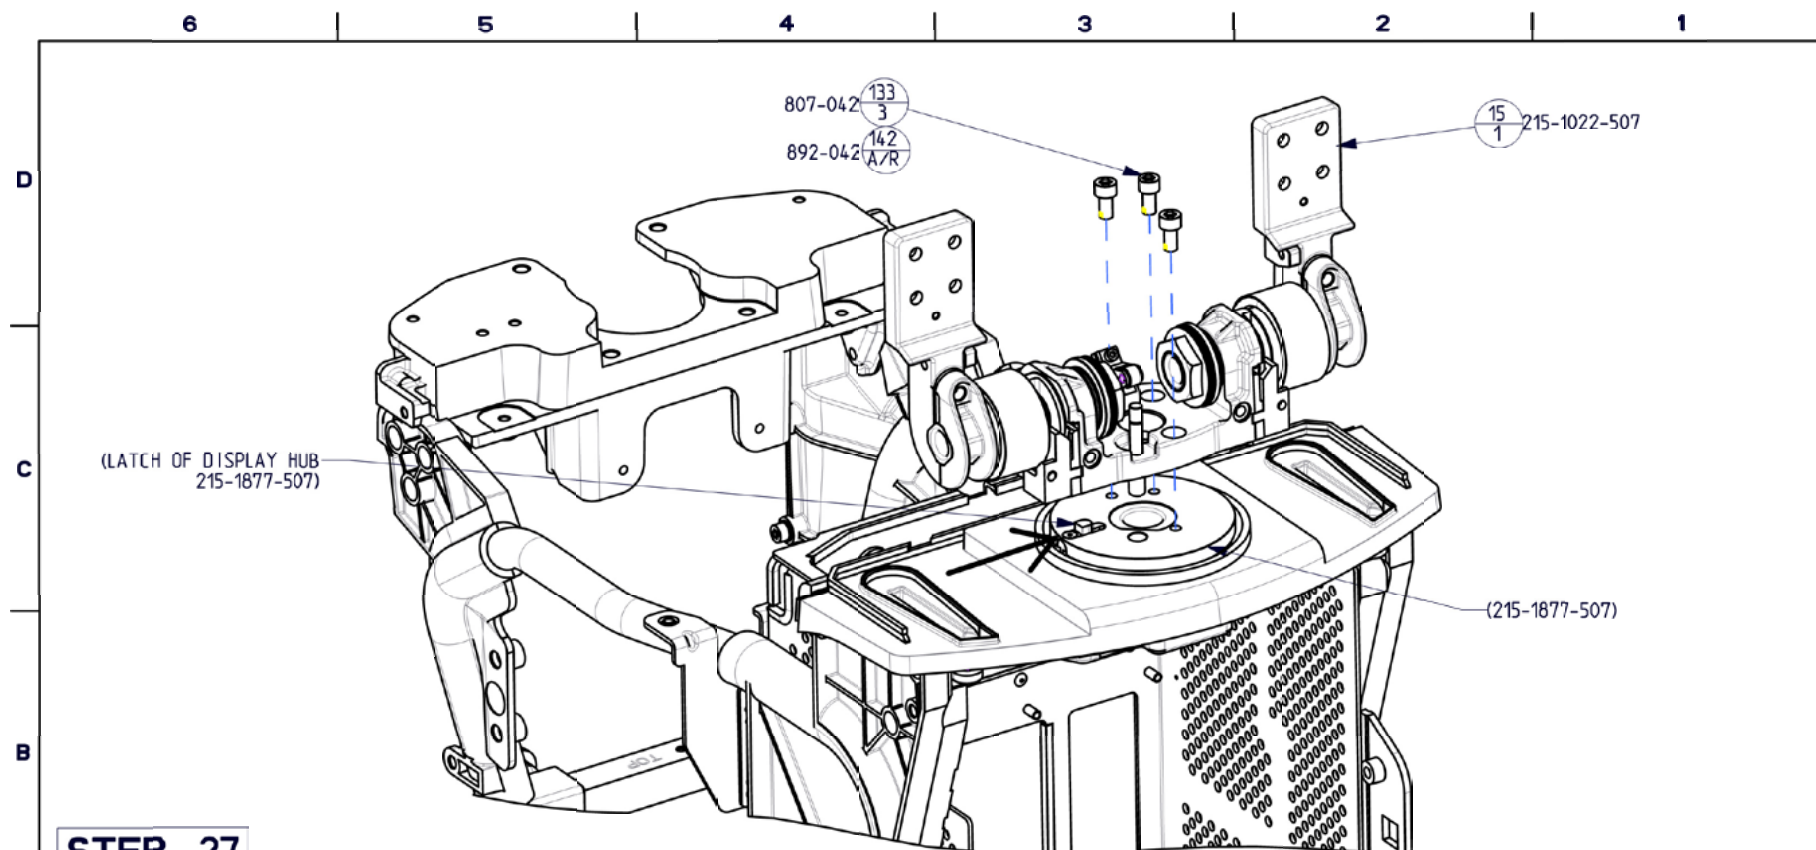
STEP 27

1. ENSURE DISPLAY HINGE 215-1022-507 SERIAL NUMBER MATCHES CONSOLE SERIAL NUMBER. STAMP DHR DATA SHEET TO CONFIRM DISPLAY HINGE SERIAL NUMBER MATCHES CONSOLE SERIAL NUMBER.
2. PRESS AND HOLD IDENTIFIED LATCH OF DISPLAY HUB 215-1877-507 TO THE RIGHT.
3. PLACE DISPLAY HINGE 215-1022-507 ONTO DISPLAY HUB 215-1877-507.
4. ADD LOCTITE 892-042 TO 3X SCREWS 807-042.
5. SECURE DISPLAY HINGE 215-1022-507 TO HUB 215-1877-507 WITH 3X SCREWS 807-042.
6. INSERT DISPLAY HINGE / DISPLAY HUB DHR DATA SHEET INTO THE OVERALL CONSOLE DHR PACKET. ENSURE SERIAL NUMBERS OF BOTH DATA SHEETS MATCH BEFORE PROCEEDING. STAMP DHR DATA SHEET TO CONFIRM DISPLAY ARM ASSEMBLY DHR DATA SHEET HAS BEEN INSERTED INTO CONSOLE DHR PACKET.

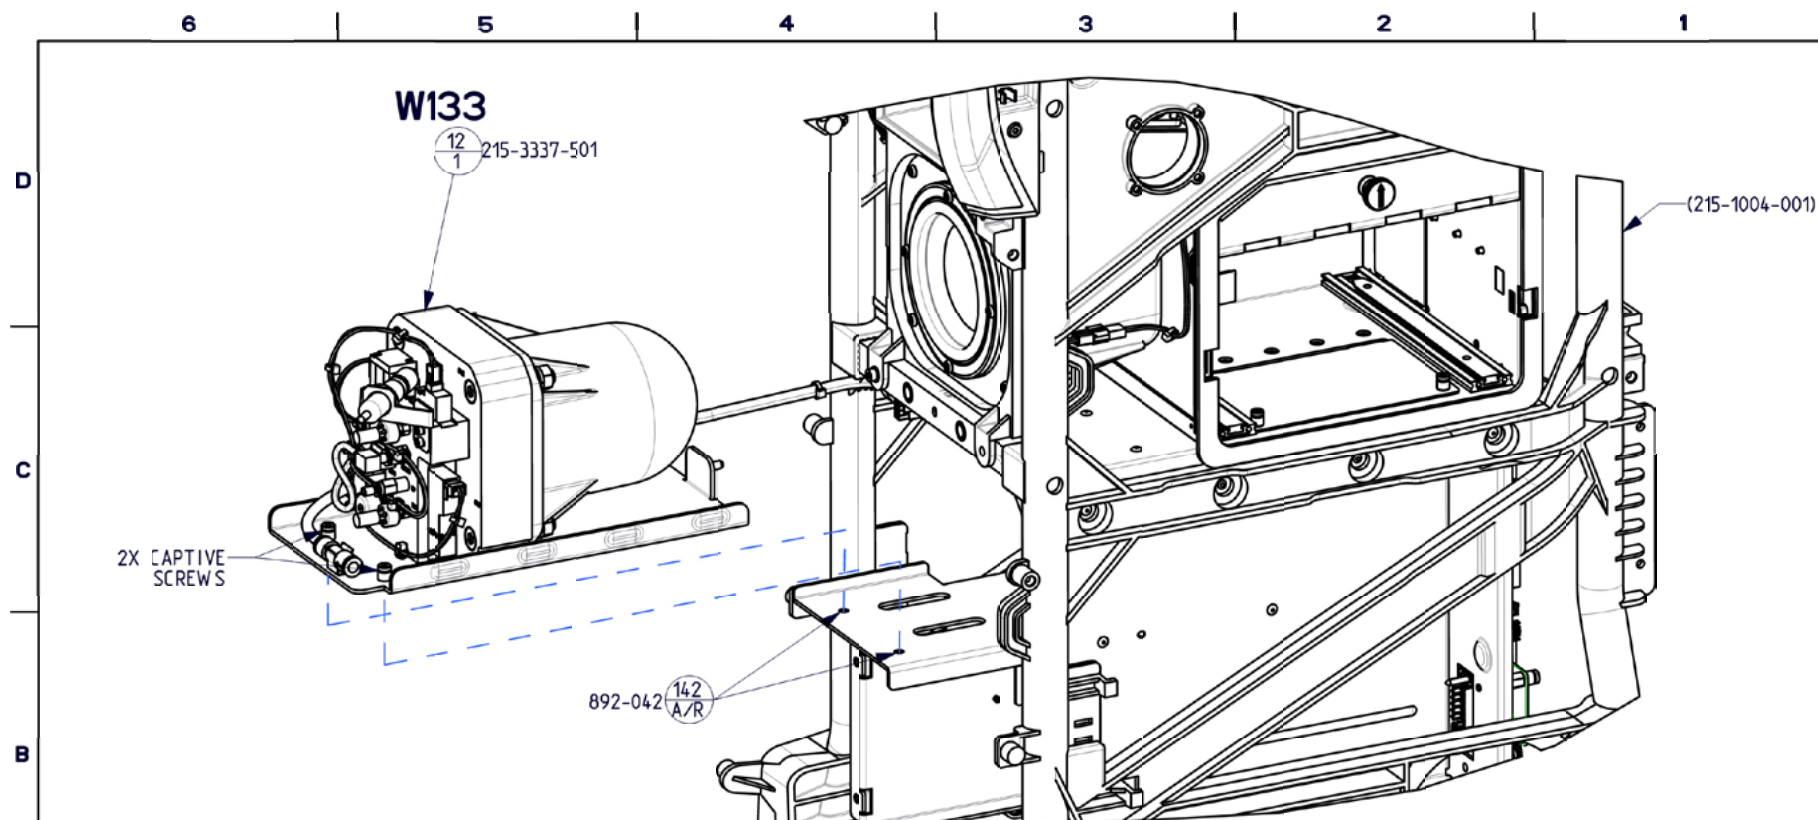
STEP 37

1. RECORD PNEUMATIC MANIFOLD REVISION 215-3337-501 ONTO DHR CHECK SHEET.
2. ADD A SMALL AMOUNT OF LOCTITE 892-042 TO 2X PEM NUTS OF CHASSIS 215-1004-001.
3. INSTALL PNEUMATICS MANIFOLD 215-3337-501 INTO CHASSIS 215-1004-001. SECURE WITH 2X CAPTIVE SCREWS.
4. ROUTE MANIFOLD CABLE W133 THRU CONSOLE TO MF10 PCB PER CABLE ROUTING FILE 215-0000-501_PROC_CABLE.ASM "W133".
5. ENSURE TUBING CONNECTIONS ON MANIFOLD 215-3337-501 ARE SECURE BY PULLING SLIGHTLY ON THE TUBING AT THE CONNECTION POINTS. IF NOT SECURE, RE-INSTALL TUBING FIRMLY AND DOCUMENT IN A PRR.

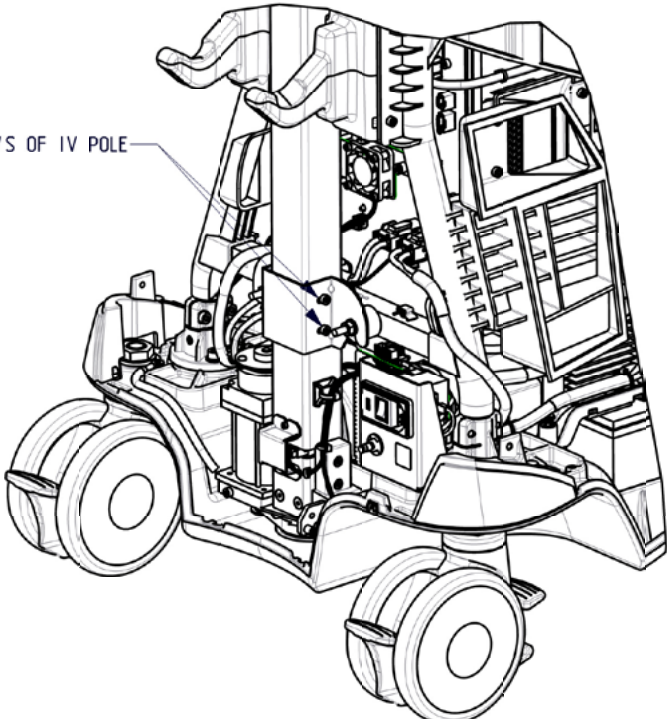
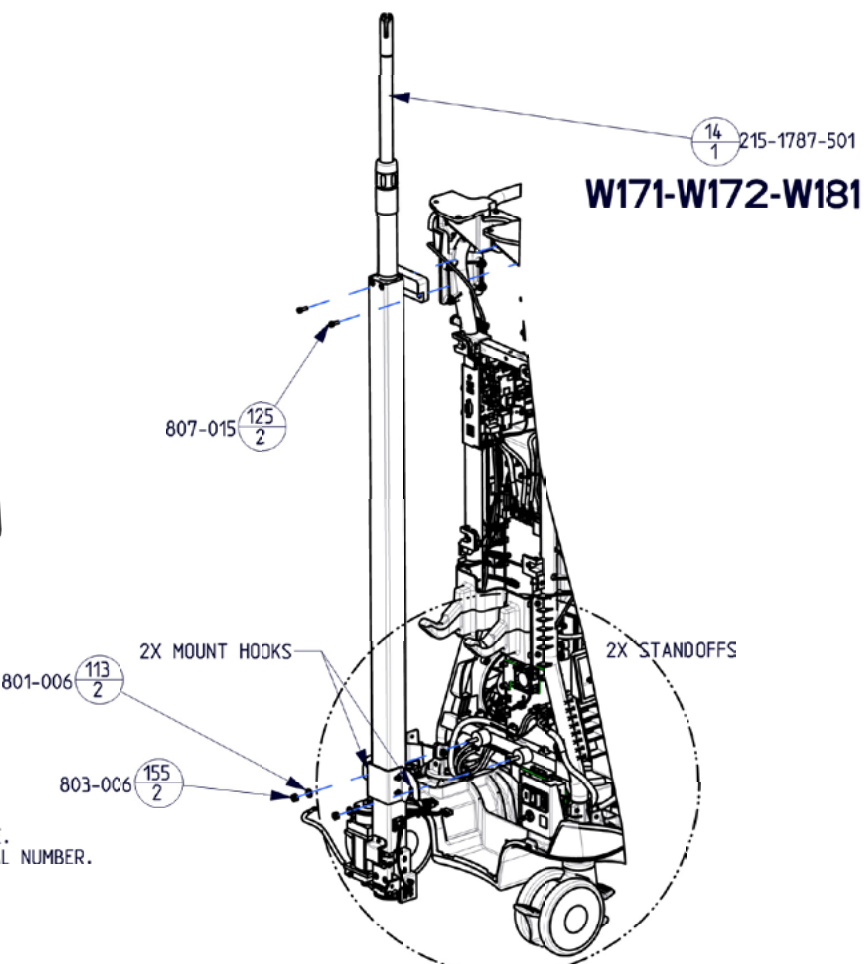
STEP 93

1. CONFIRM SERIAL NUMBER OF IV POLE 215-1787-501 MATCHES SERIAL NUMBER OF CONSOLE. STAMP DHR DATA SHEET TO CONFIRM IV POLE SERIAL NUMBER MATCHES CONSOLE SERIAL NUMBER.
2. INSERT IV POLE DHR DATA SHEET INTO OVERALL CONSOLE DHR PACKET.
3. INSTALL IV POLE ASSY 215-1787-501 ONTO CHASSIS WITH 2X SCREWS 807-015.
4. INSTALL 2X WASHERS 801-006 AND 2X NUTS 803-006 ONTO IDENTIFIED STANDOFFS OF CHASSIS ABOVE.
5. FULLY TIGHTEN 2X IDENTIFIED SCREWS OF IV POLE 215-1787-501 SHOWN IN DETAIL A.
6. ROUTE 2X IV POLE CABLES (W171 & W172) TO MFIO PCB PER CABLE ROUTING FILE 215-0000-501_PROC_CABLE.ASM "W171-W172-W181."

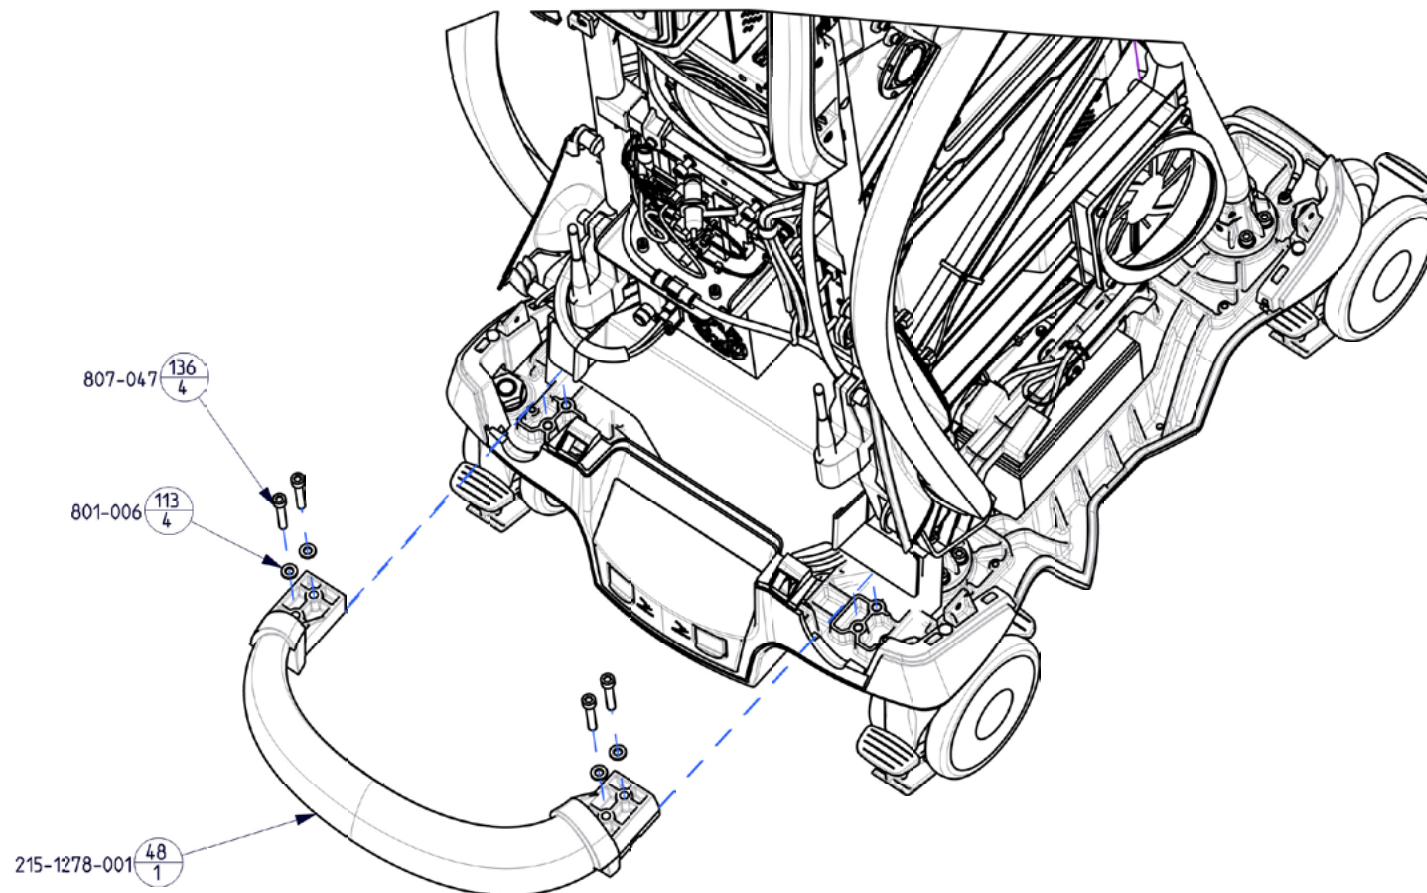
STEP 114

1. INSTALL FRONT BUMPER 215-1278-001 ONTO BASE 215-1219-001 WITH 4X WASHERS 801-006 AND 4X SCREWS 807-047.

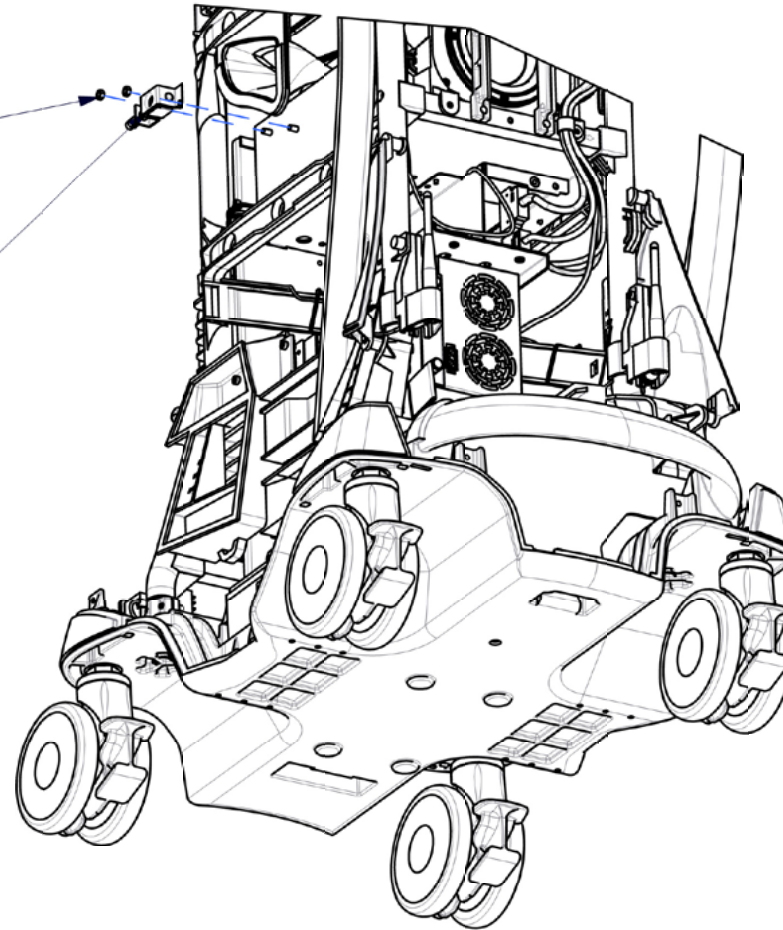
STEP 115

1. ASSEMBLE 215-2339-501 PER 215-2339-501.DRW, LATEST REV. PERFORM 2-WAY CHECK PER DHR CHECK SHEET.
2. INSTALL LATCH FROM 215-2339-501 ONTO CHASSIS WITH 2X NUTS 803-005.

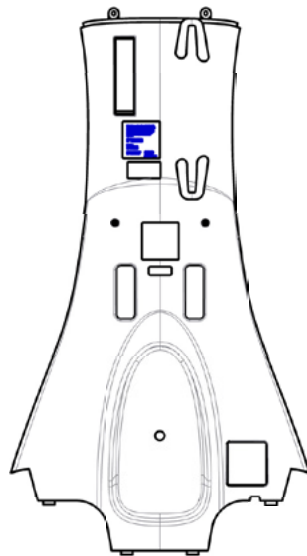
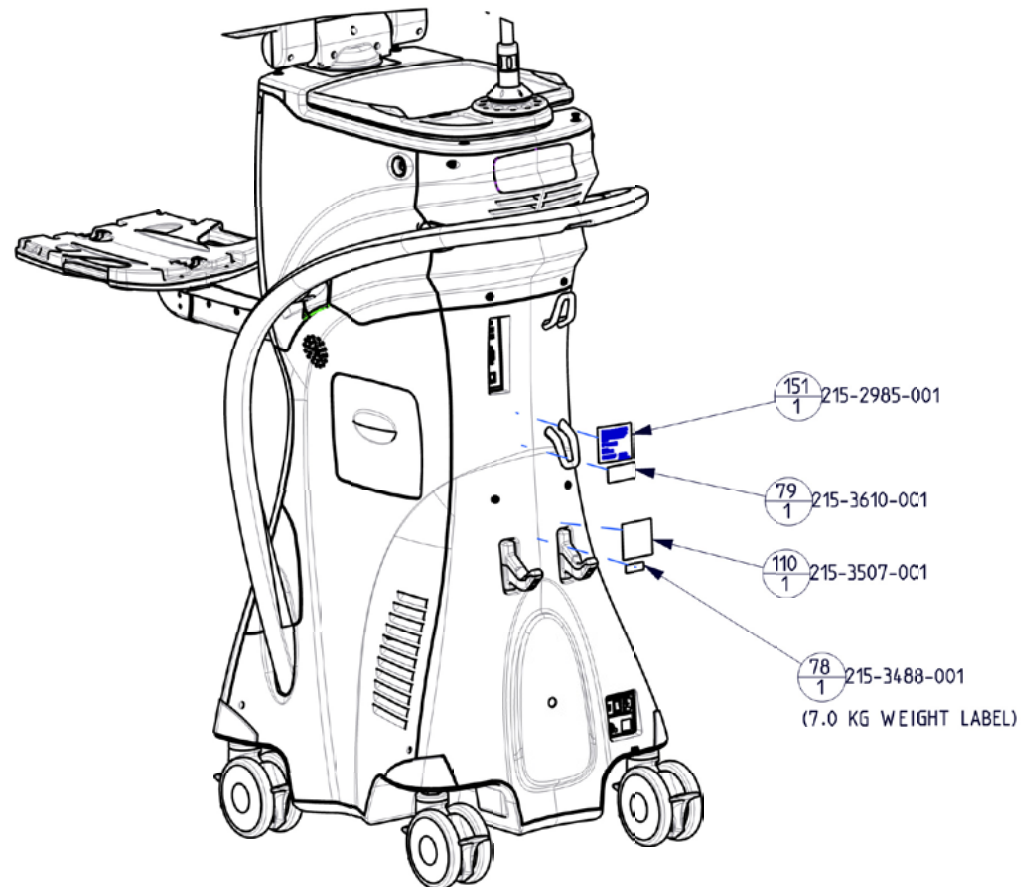
STEP 138

1. INSTALL CENTURION WIRELESS LABEL 215-2985-001 ONTO LOWER REAR PANEL IN LOCATION SHOWN.
2. INSTALL REAR PANEL INFO LABEL 215-3507-001 ONTO LOWER REAR PANEL IN LOCATION SHOWN.
3. INSTALL 7.0 KG WEIGHT LABEL 215-3488-001 IN APPROXIMATE LOCATION/ORIENTATION SHOWN IN DETAIL A ON LOWER REAR PANEL.
4. INSTALL IMPORTER LABEL 215-3610-001 ONTO LOWER REAR PANEL IN LOCATION SHOWN.

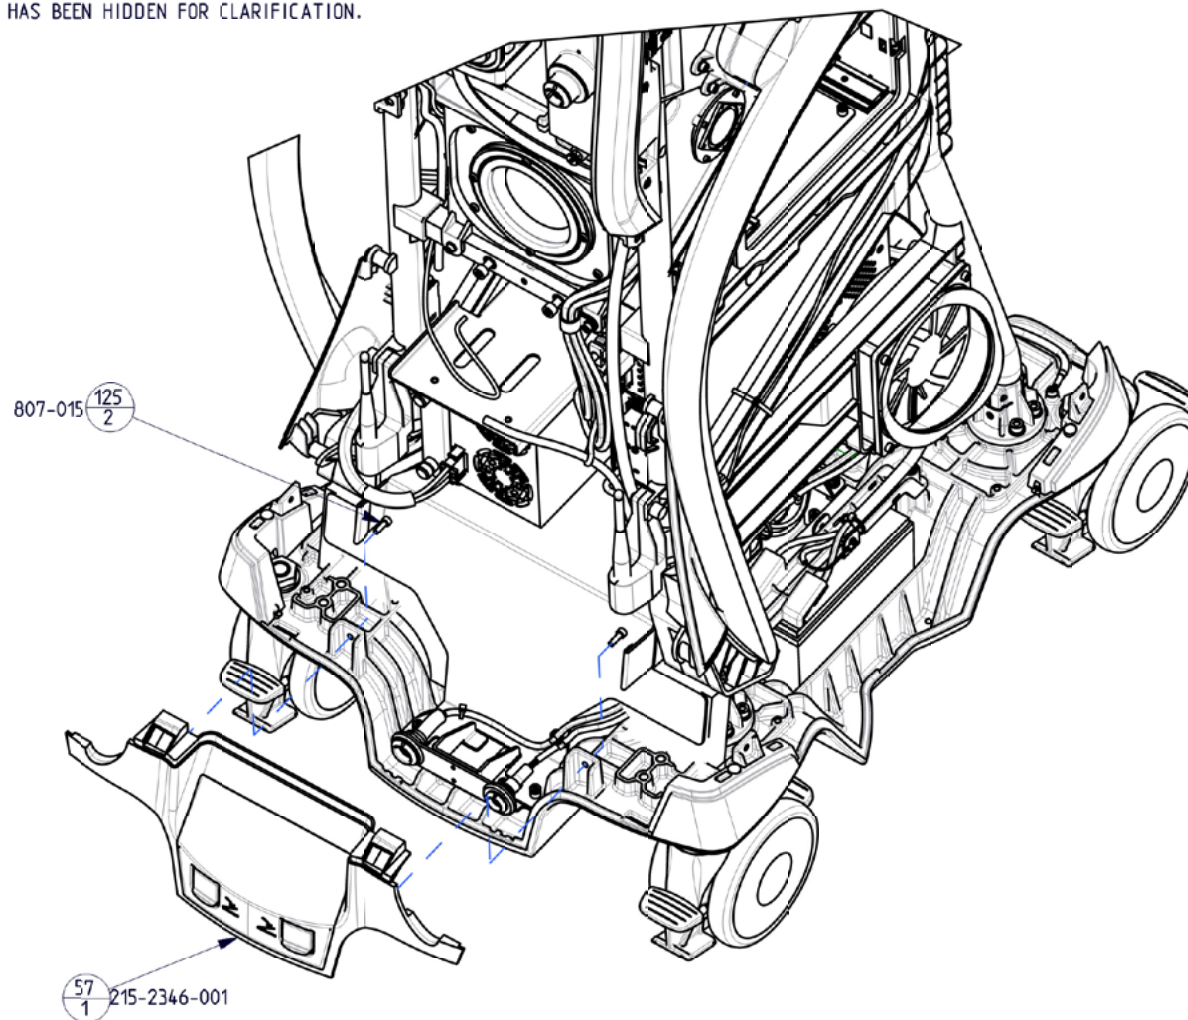
STEP 107

1. INSTALL FRONT FOOT HANDLE PANEL 215-2346-001 ONTO BASE 215-1219-001 AND SECURE WITH 2X SCREWS 807-015.

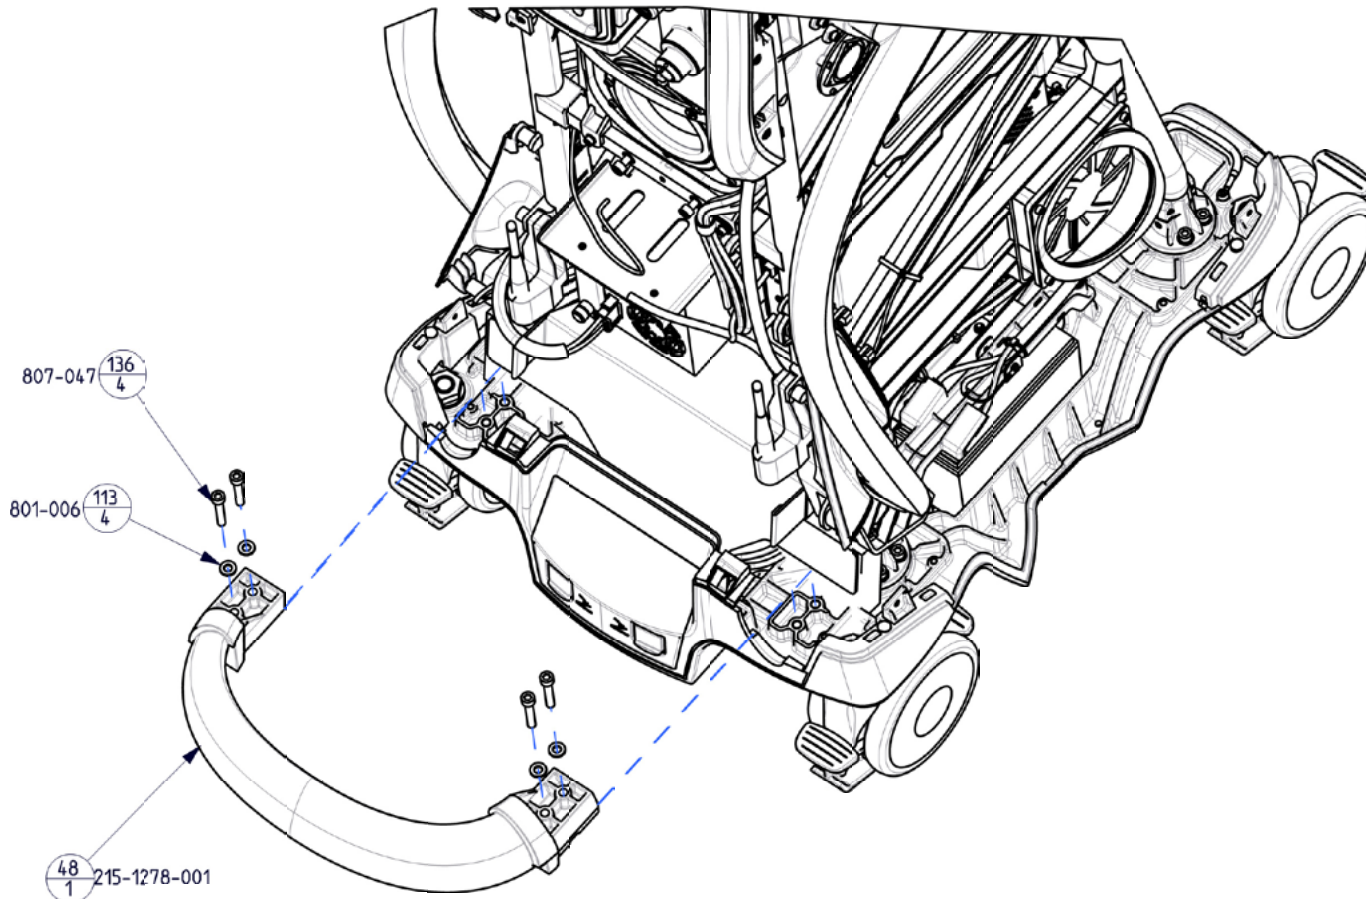
STEP 108

1. INSTALL FRONT BUMPER 215-1278-001 ONTO BASE 215-1219-001 WITH 4X WASHERS 801-006 AND 4X SCREWS 807-047.

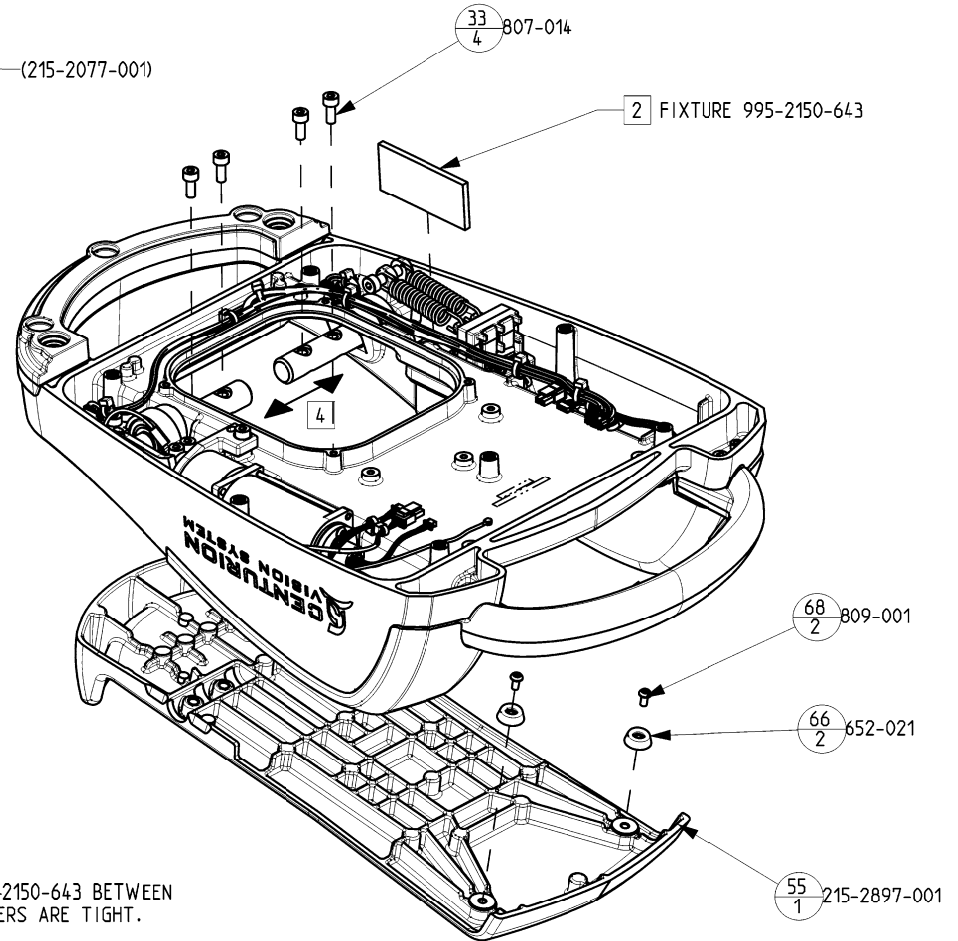
STEP 11

DETAIL F
(CORRECT ALIGNMENT)
SCALE 1:1

1. INSTALL BUMPERS TO TREADLE BEFORE INSTALLING TREADLE TO FOOTSWITCH.
- 2 ROTATE SPRINGS TO FULL TRAVEL, AND THEN TEMPORARILY INSERT FIXTURE 995-2150-643 BETWEEN SPRINGS TO FACILITATE TREADLE INSTALLATION. REMOVE FIXTURE ONCE FASTENERS ARE TIGHT.
3. START ALL FASTENERS IN AXLES.
- 4 APPLY OUTWARD PRESSURE TO ENSURE AXLES (ITEMS 14, 15) ARE SEATED FIRMLY IN BEARING WHILE TIGHTENING AXLE FASTENERS.
5. ALIGN GEARS TO MESH EVENLY, THEN TIGHTEN GEARS FASTENERS. SEE ALIGNMENT DETAILS.

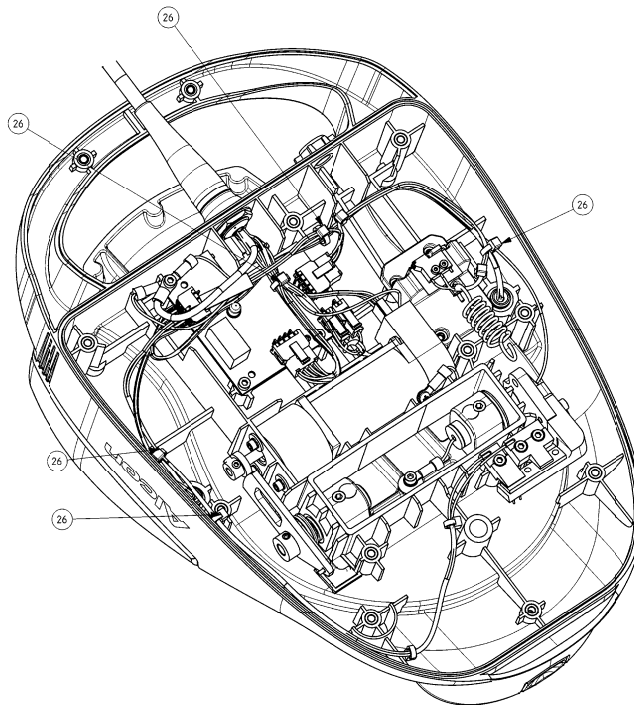
27 USE TIE WRAPS (ITEM 26) TO NEATLY GROUP BUNDLES OF WIRES TOGETHER UNIFORMLY. ROUTE ALL CABLES AND WIRES PER DRAWING VIEWS SHOWN IN THIS DOCUMENT. ENSURE THERE IS ENOUGH EXCESS WIRE IN LOCATIONS REQUIRING PART MOVEMENT. CHECK THAT NO WIRES ARE IN LOCATIONS THAT WOULD INTERFERE WITH FASTENER BOSSES OR OTHER MOVING PARTS SUCH AS GEARS OR SPRINGS.

28 MARK A1/1 ON THE 8 PIN MOLEX CONNECTOR OF THE EXTERNAL CABLE. MARK A1/2 ON MICROSWITCH CONNECTOR MARK A1/3 ON CONNECTOR (ITEM 28). MARK A1/4 ON THE 2 PIN MOLEX CONNECTOR OF THE CABLE AND MARK A1/5 ON MOTOR LEADS CONNECTOR.

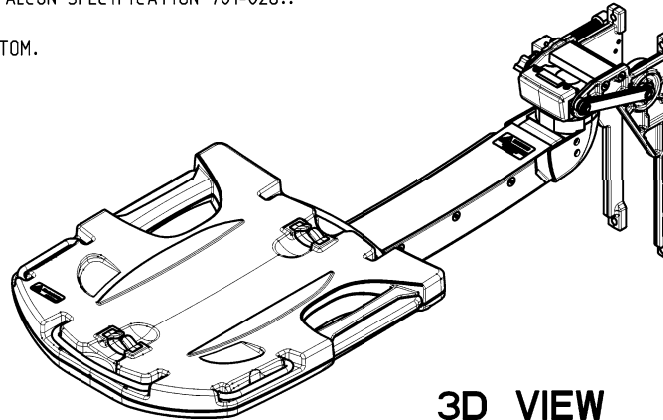
3D VIEW

8. 215-1091-502S IS MADE FROM ONE 215-1091-502

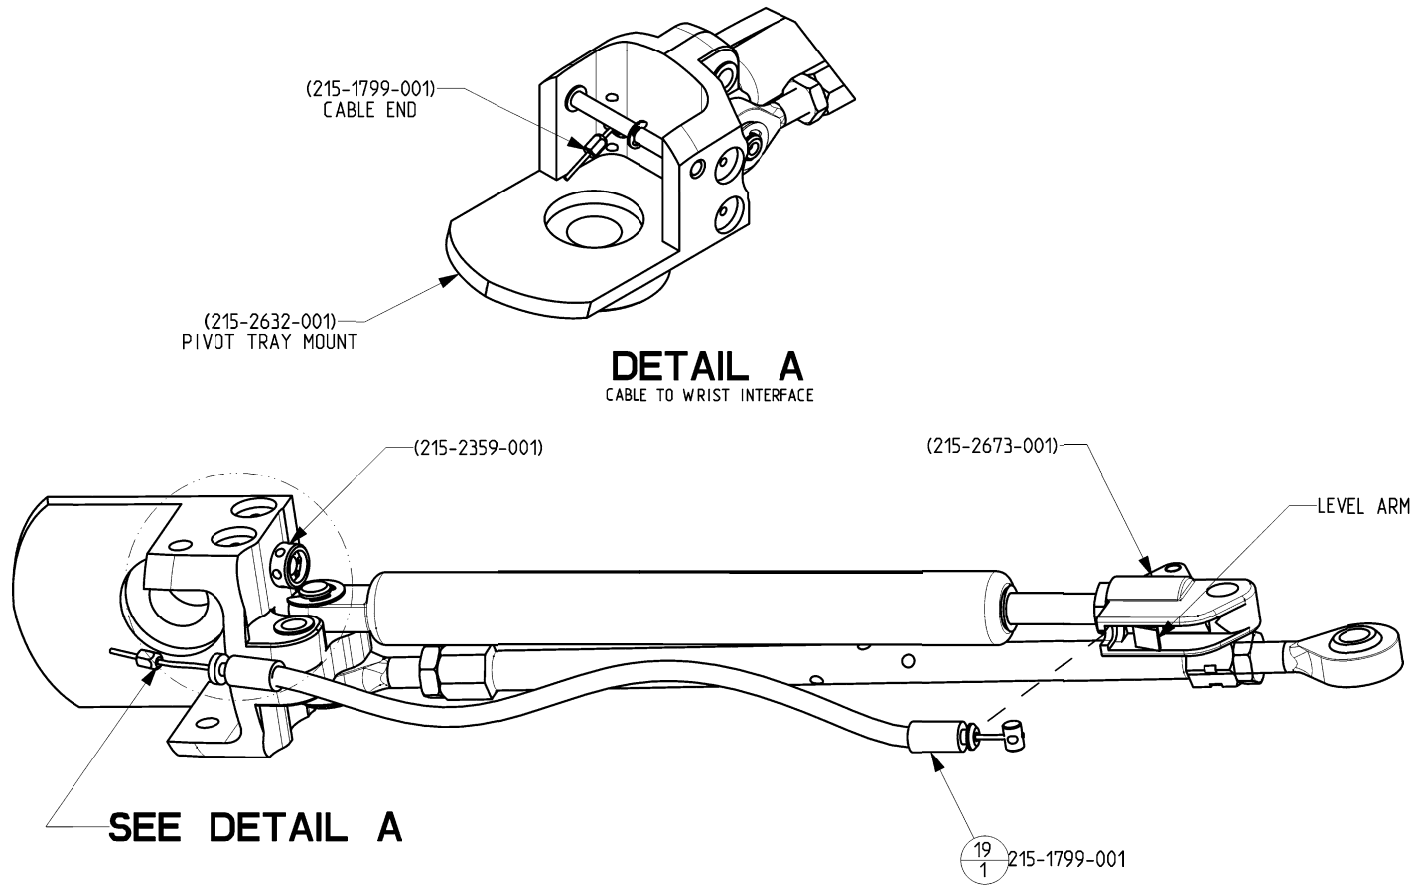
STEP 10

1. HOOK END OF BRAKE CABLE 215-1799-001 INTO LEVEL ARM OF GAS SPRING 215-2673-001.
2. INSERT OTHER END OF BRAKE CABLE 215-1799-001 THROUGH HOLE OF SCREW 215-2359-001. SEE DETAIL A FOR DETAILS.

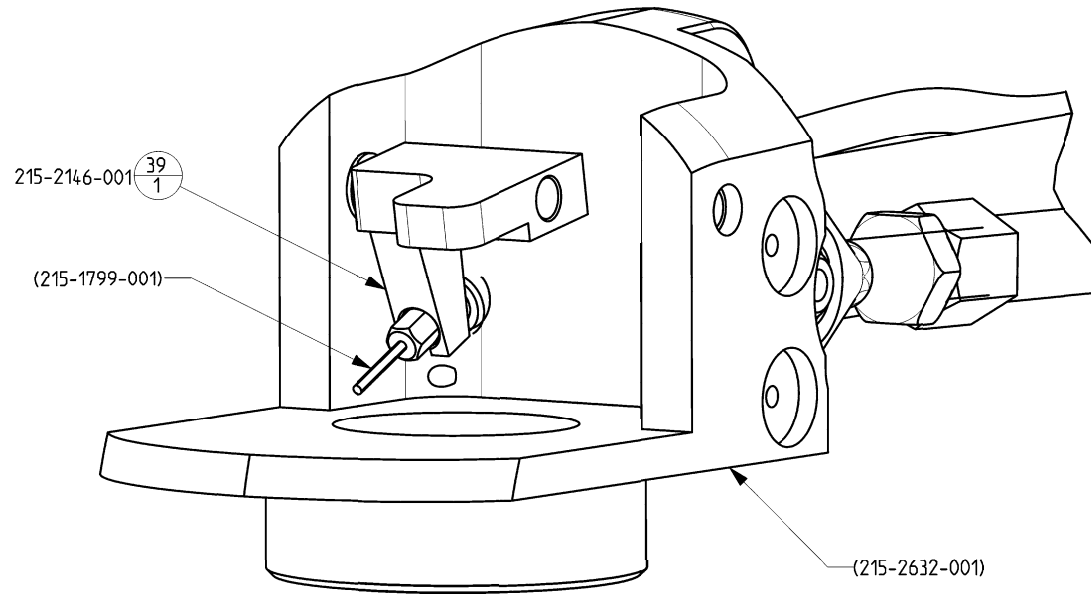
STEP 12

1. HOOK RELEASE LEVER 215-2146-001 ONTO END OF BRAKE CABLE 215-1799-001 AS SHOWN.

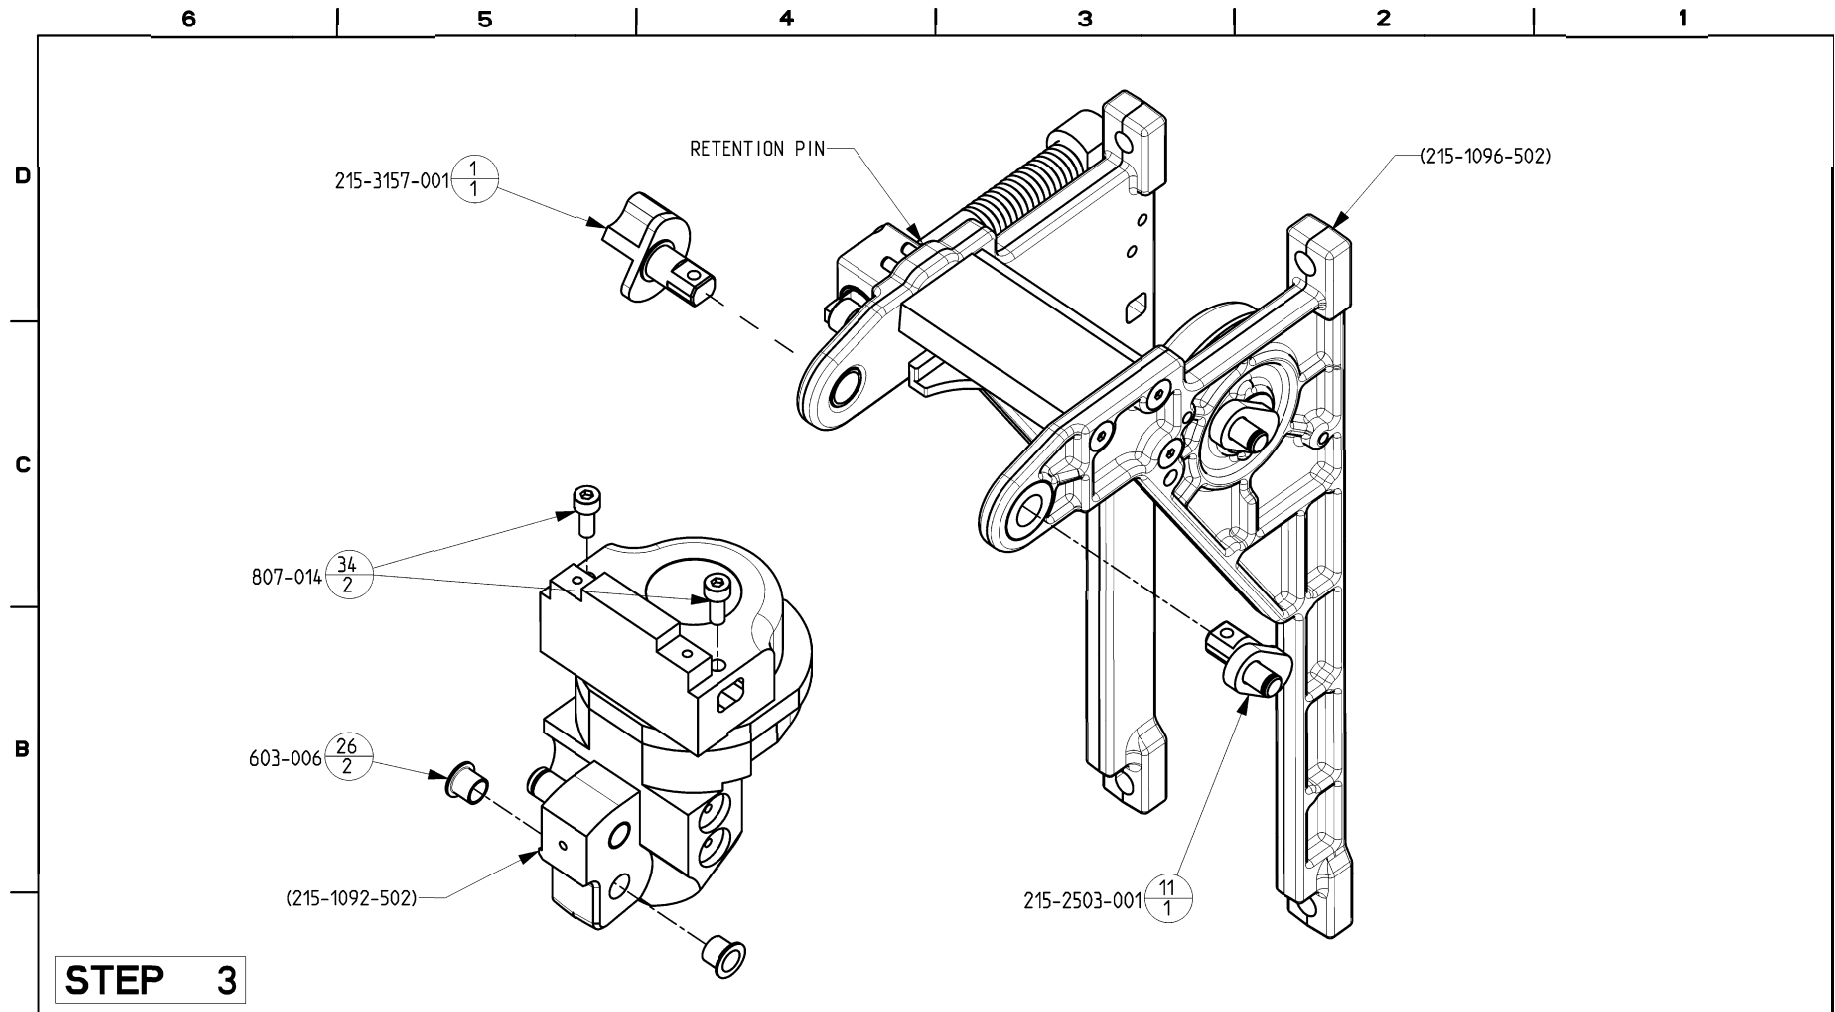
SIZE	B	DRAWING NUMBER	215-1091-503X	REV	B
SCALE: 7:8			SHEET 4 OF 27

1. INSERT KNUCKLE 215-1092-502 INTO FRAME MOUNT 215-1096-502 AND SECURE IN PLACE WITH CAM 215-3157-001 AND FRONT LINKAGE 215-2503-001 IN ORIENTATION SHOWN.
2. REMOVE 3MM NUT DRIVER RETENTION PIN FROM FRAME MOUNT 215-1096-502.
3. INSTALL 2X SCREWS 807-014 INTO KNUCKLE ASSY 215-1092-502.
4. PRESS 2X BUSHING 603-006 INTO IDENTIFIED LOCATIONS OF KNUCKLE ASSY 215-1092-502.

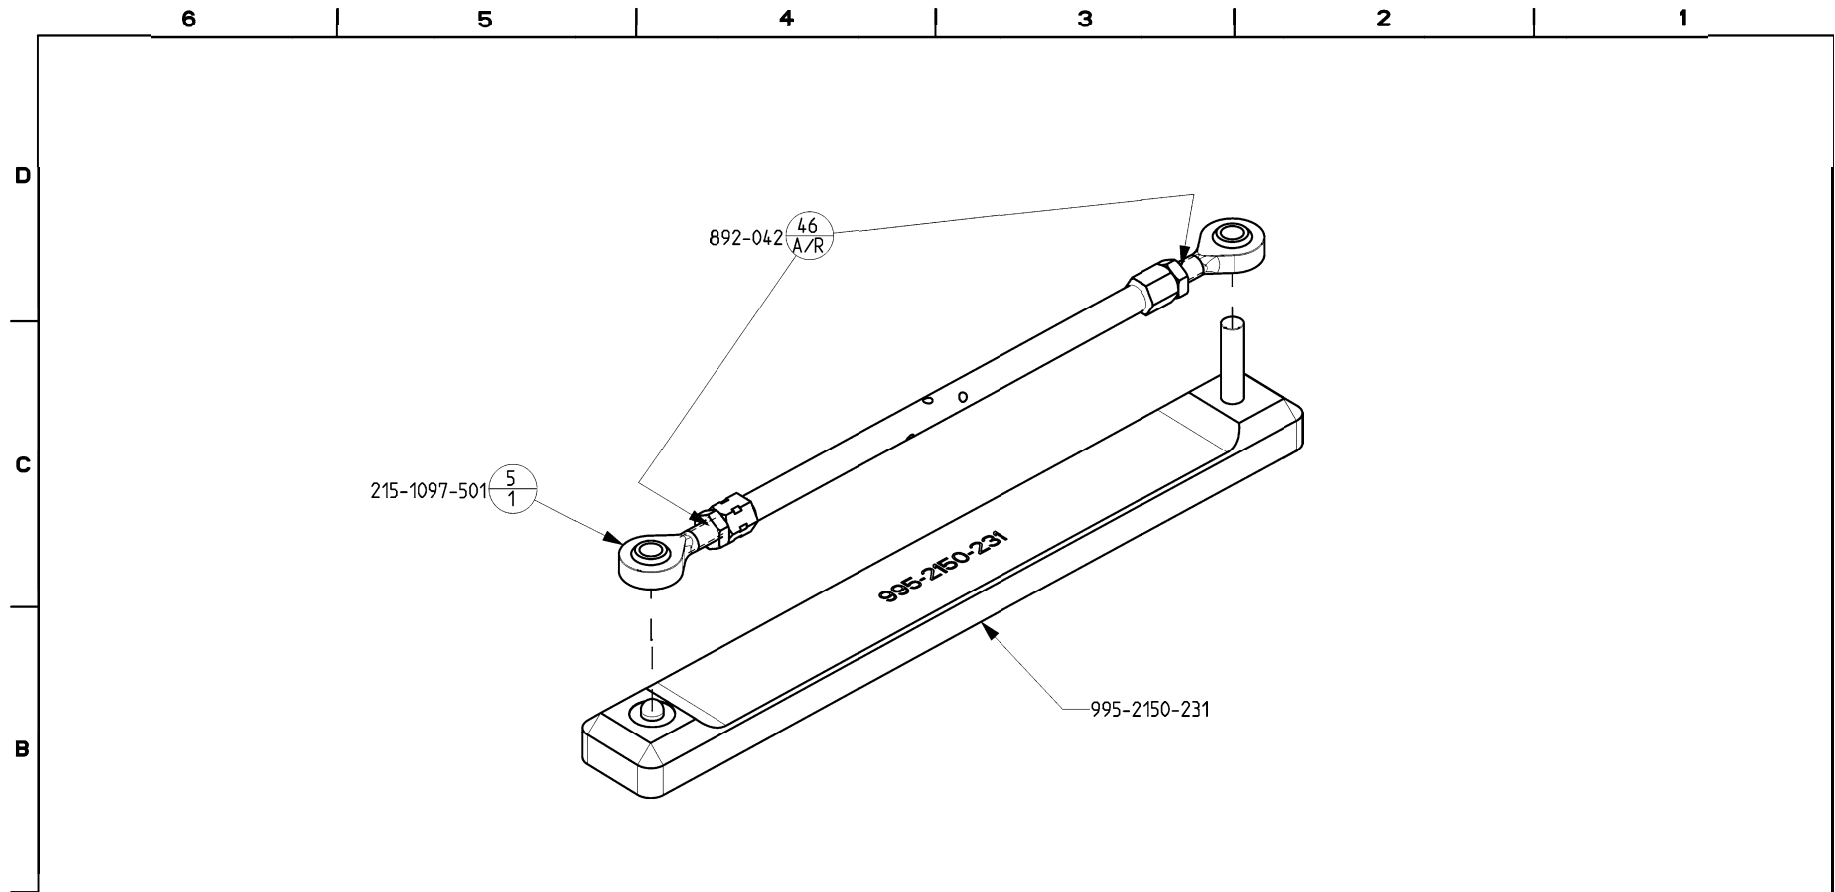
STEP 7

1. CONFIRM TURNBUCKLE 215-1097-501 IS SET TO PROPER LENGTH BY INSTALLING ONTO FIXTURE 995-2150-231 AS SHOWN. ADJUST TURNBUCKLE AS NECESSARY TO INSTALL.
2. FULLY TIGHTEN 2X NUTS ONTO SHAFT OF TURNBUCKLE 215-1097-501.
3. ADD LOCTITE 892-042 TO THE OUTSIDE OF 2X NUTS AS SHOWN.
4. REMOVE TURNBUCKLE 215-1097-501 FROM FIXTURE 995-2150-231.

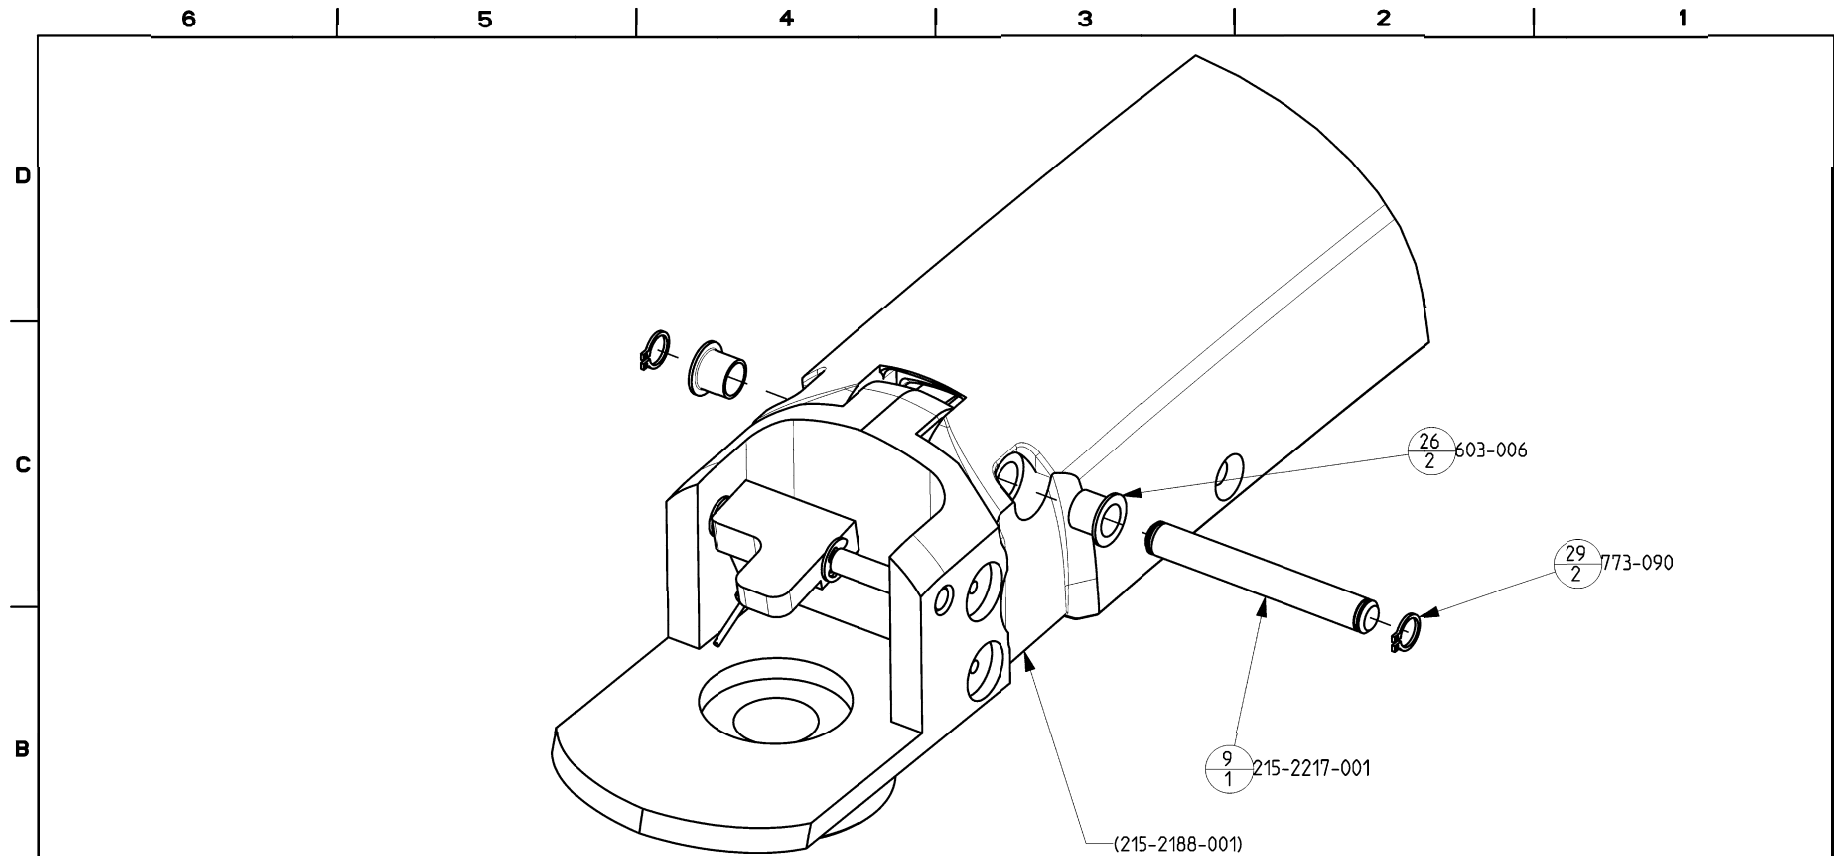
STEP 17

1. INSERT 2X BEARINGS 603-006 INTO ARM 215-2188-001 IN LOCATIONS SHOWN.
2. INSERT PIN 215-2217-001 INTO BOTTOM ARM 215-2188-001.
3. INSTALL 2X C-CLIPS 773-090 ONTO END OF PIN 215-2217-001.
4. ENSURE 2X C-CLIPS ARE FULLY INSTALLED BEFORE PROCEEDING.

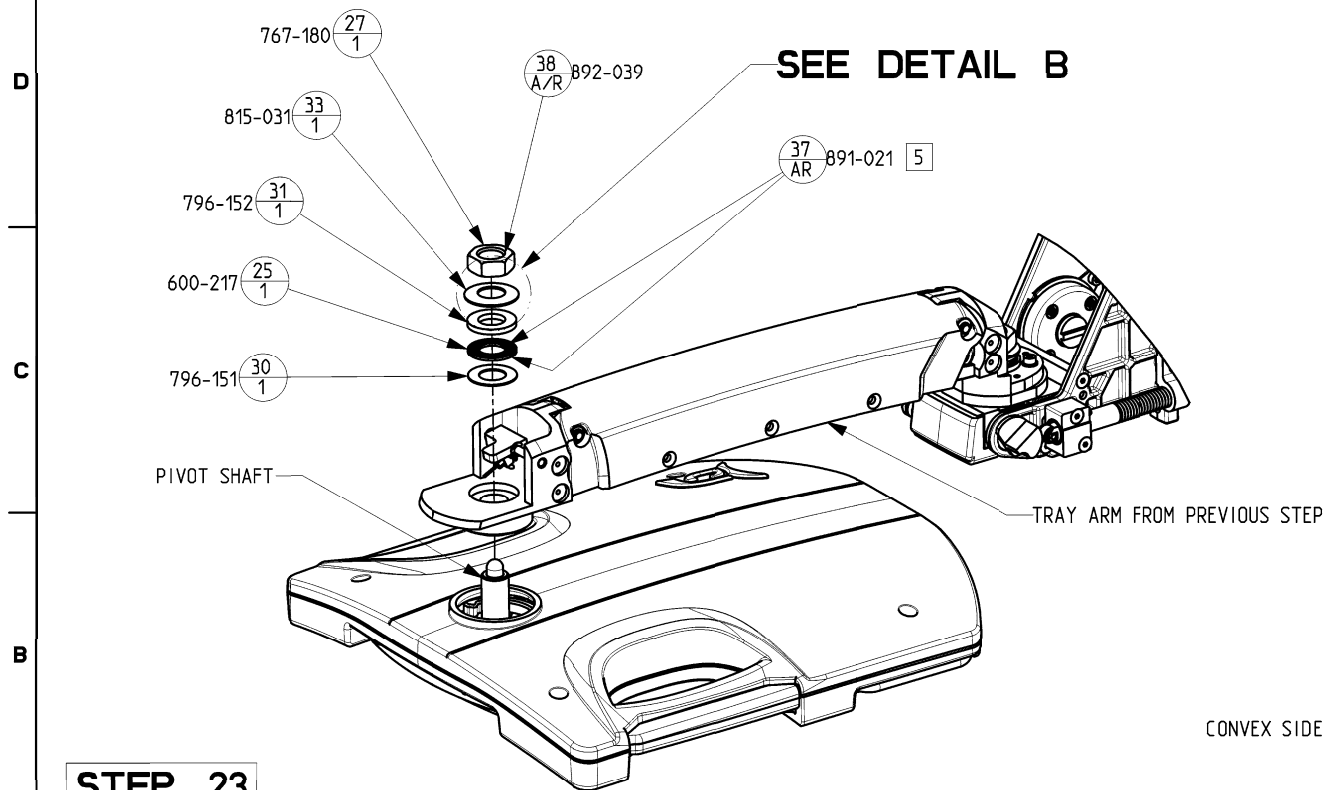
STEP 23

1. PLACE TRAY ASSEMBLY FROM PREVIOUS STEP ONTO PIVOT SHAFT.
2. PLACE WASHER 796-151 ONTO PIVOT SHAFT.
3. APPLY GREASE 891-021 TO BOTH SURFACES OF THRUST BEARING 600-217 AND PLACE BEARING ONTO PIVOT SHAFT.
4. PLACE WASHERS 796-152 AND 815-031 WITH CONVEX SIDE UP (SEE DETAIL B) ONTO PIVOT SHAFT.
5. APPLY A SMALL AMOUNT OF LOCTITE 892-039 ONTO THREADS OF NUT 767-180 AND INSTALL NUT ONTO PIVOT SHAFT.
FULLY TIGHTEN NUT THEN LOOSEN 1/2 TURN.

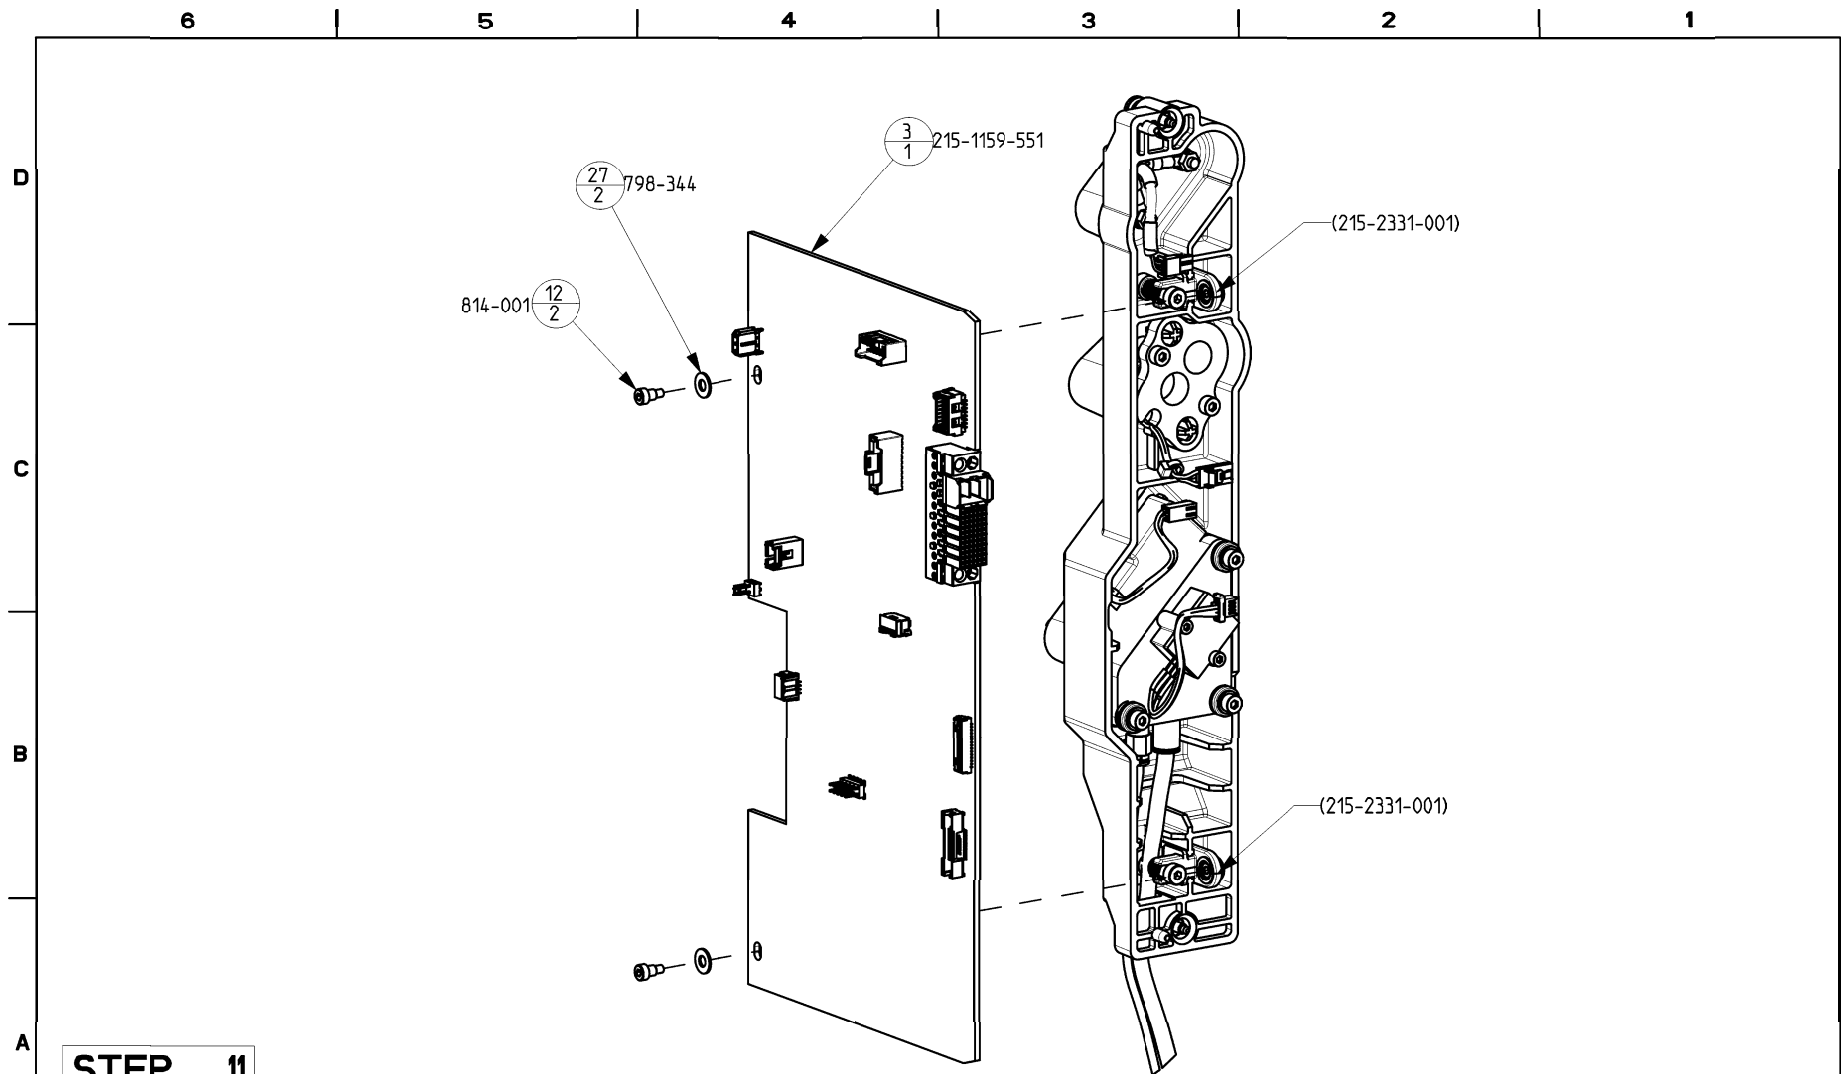
STEP 11

1. RECORD PCB SERIAL NUMBER AND REVISION LETTER ONTO DHR DATA SHEET, AND CAPTURE IN JDE.
2. INSTALL PCB 215-1159-551 ONTO BRACKETS 215-2331-001 WITH 2X SCREWS 814-001 AND 2X WASHERS 798-344.
